### Siesta Key 89 Beach Daytona, FL

#### Overview

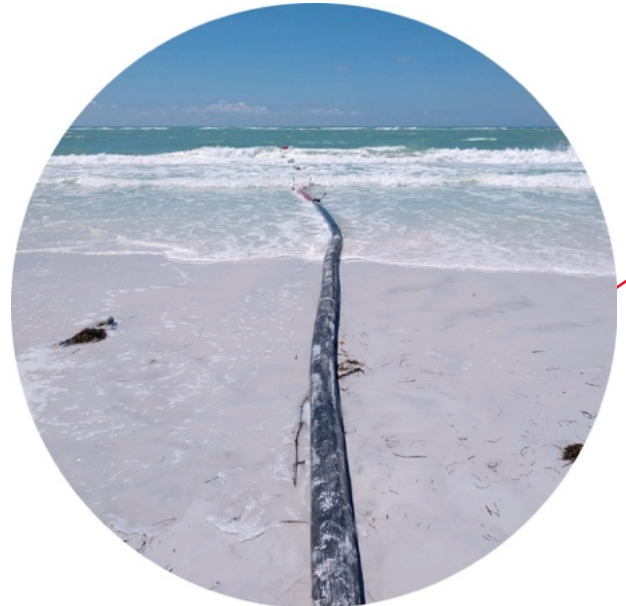
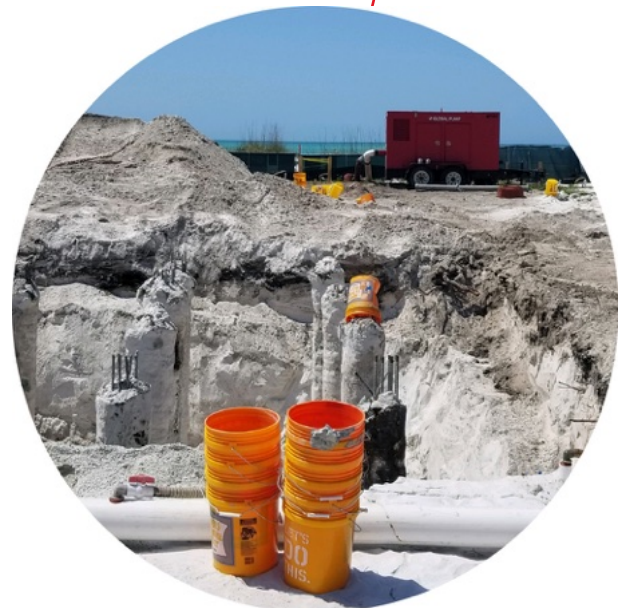
The completed system consisted of one 6" Global Standard Trash pump with 6" QD layflat discharge line to the Gulf, with approximately 150' of 6" QD HDPE pipe out into the Gulf of Mexico. The decision was made to set fused and flanged HDPE on the beach to form as rigid a discharge pipe as possible. This pipe was then held in place with concrete anchors and buoys.

Initial attempts to set the discharge line proved difficult due to the tidal conditions breaking apart the discharge line. The decision was made to set fused and flanged HDPE on the beach to form as rigid a discharge pipe as possible. The discharge line was routed into the Gulf of Mexico and was held in place with concrete anchors and buoys. In order to install the discharge line, a handful of MERSINO employees had to dive in to help set and place the line on the anchor tie-downs under water. The system performed very well and the pit is bone dry. Despite the out-of-the-ordinary challenges, the project was completed on time and the client was satisfied.
